# Improving Air Quality and Protecting Equipment for a Power Transformer Manufacturer

## Customer Case Study

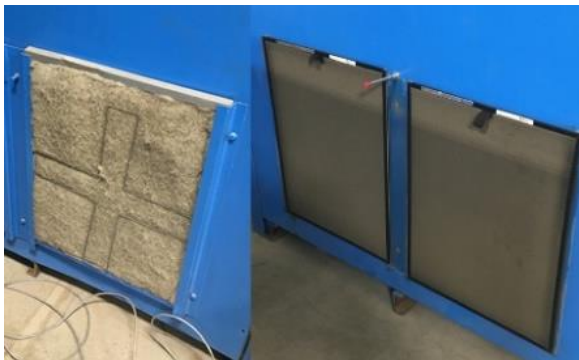
*Compressor intakes protected by polyester media on the left-side and the PreVent® screens on the right.*

The new screens were sized to fit each compressor unit and prevent debris from getting clogged and breaking-down, which could cause production down-time and costly repairs.

Months after the initial set of PreVent® screens were installed, the customer ordered more of them to replace the polyester media used to protect their compressor intake.

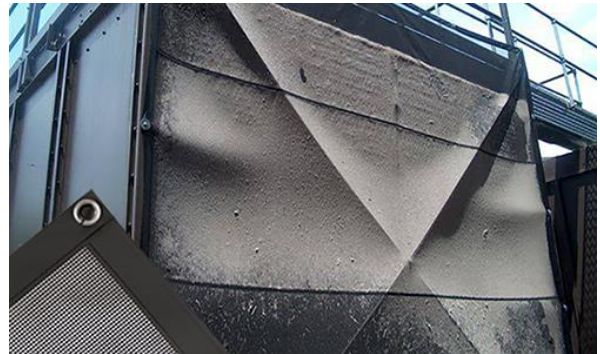
Permatron PreVent® air intake filter screens were also installed on each of the customer's cooling towers to keep debris out of the water that circulates throughout the plant.

*Cooling tower with a PreVent® screen attached*

As a result, the maintenance team no longer exhausts valuable resources power-washing the cooling coils, as they can easily remove and clean the screens in minutes.
